**FINAL
REMEDIAL INVESTIGATION REPORT**

**REMEDIAL INVESTIGATION OF
BURNING GROUNDS, SANITARY LANDFILL,
AND PISTOL RANGE AREAS
(REMAINING PROPERTY OF THE U.S.
GOVERNMENT) CORNHUSKER ARMY AMMUNITION
PLANT GRAND ISLAND, NEBRASKA**

APPENDIX A

PHOTOGRAPHS

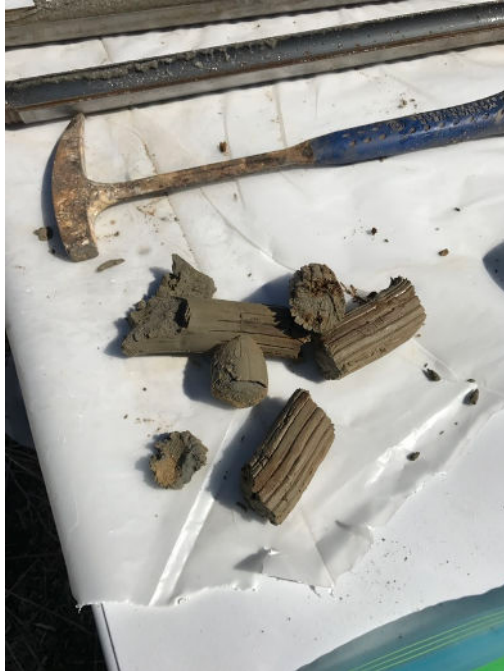
**Photograph 1 Notes:**

Lean clay encountered in the 20B-MW06 borehole between topsoil and Upper Grand Island Aquifer (UGIA) sand. Wet, iron-stained very-coarse-sand sized clasts are also visible in the photograph.

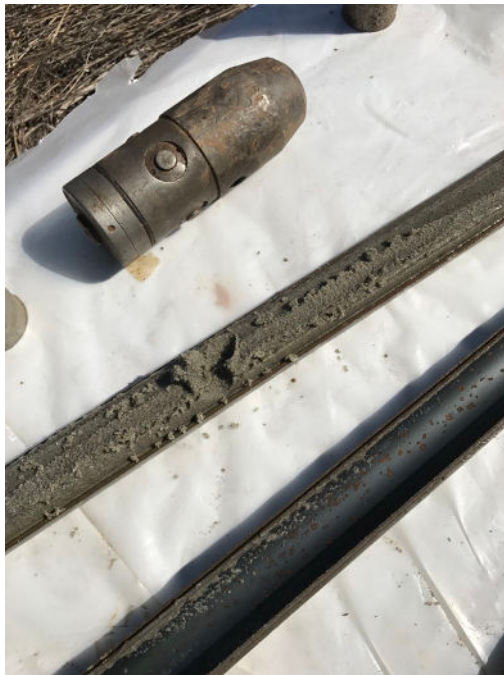
**Photograph 2 Notes:**

Clean, well-graded, sub-rounded, medium to very coarse sand of the UGIA and Lower Grand Island Aquifer (LGIA) that extended from 11 feet to 36.5 feet below grade.

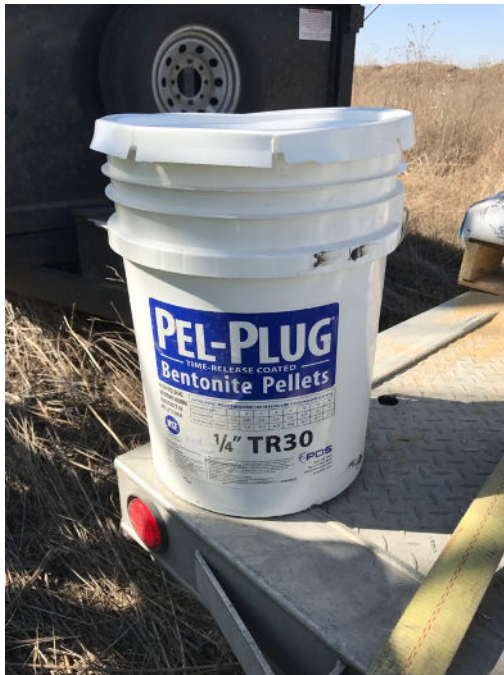
Photograph 4 Notes:

Bentonite plug that were installed at 20B-MW06 from 20-24ft below grade. Bentonite pellets are “time release” to ensure installation at the appropriate interval prior to curing.

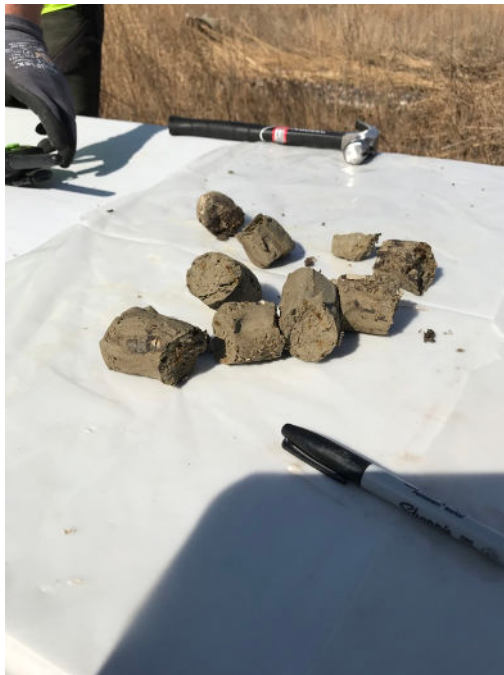
Photograph 2 Notes:

Lean clay encountered in 20B-MW08 between the topsoil and the UG1A. Iron stained, wet, very-coarse-sand sized clasts illustrated in photograph.

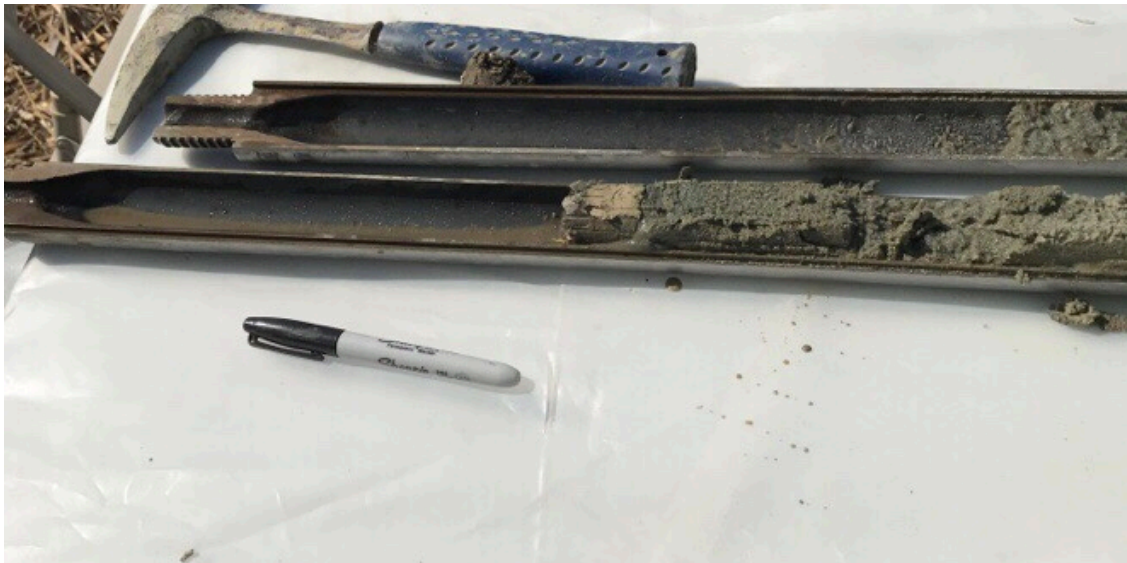
**Photograph 4 Notes:**

The clay sand interface at monitoring well 20B-MW08 was encountered at 14.75 feet bgs. UGIA sand is identical to that of monitoring wells MW05 and MW06 in Tract 20B.

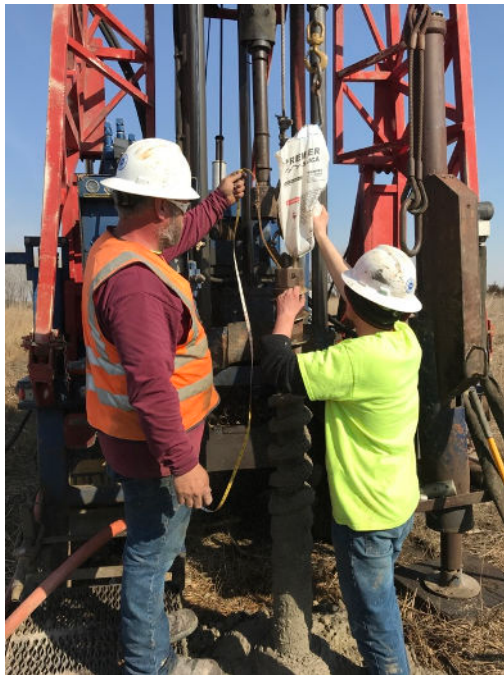
**Photograph 6 Notes:**

GSI crew pours sand pack around the screen of monitoring well 20B-MW08. The sand pack extends two feet above the top of the screen.

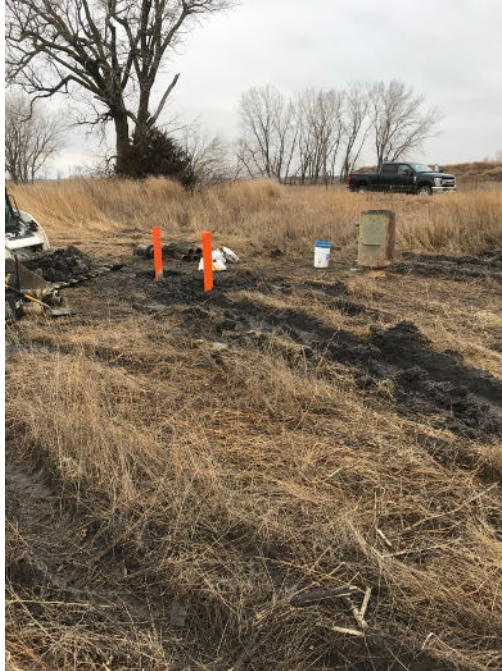
**Photograph 1 Notes:**

Wells 20B-MW07 and 20B-MW08 have been installed (excluding concrete pads and bollards). Tire ruts from wet conditions are also shown.

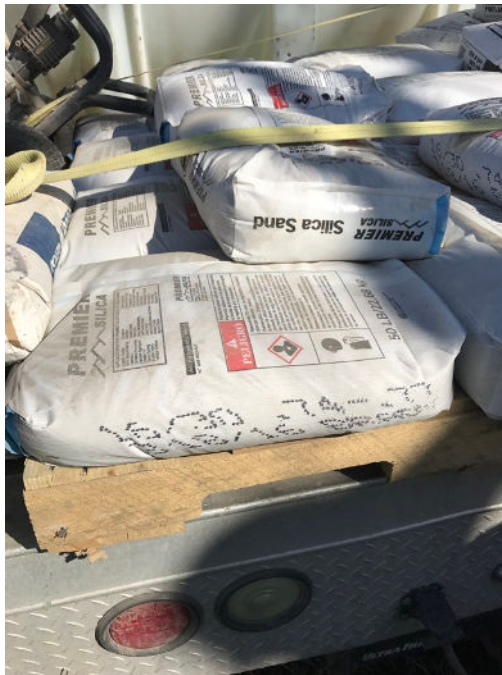
**Photograph 2 Notes:**

16/30 sand pack used in the boreholes from two feet above the top of the screen to the bottom of the borehole.

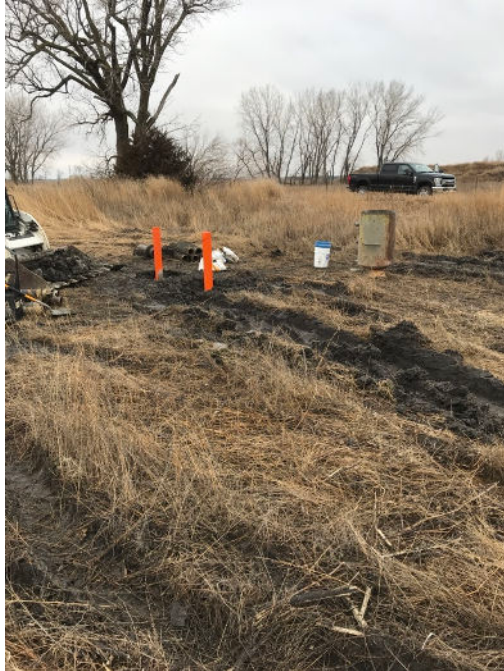
**Photograph 1 Notes:**

Wells 20B-MW07 and 20B-MW08 have been installed (excluding concrete pads and bollards). Tire ruts from wet conditions are also shown.

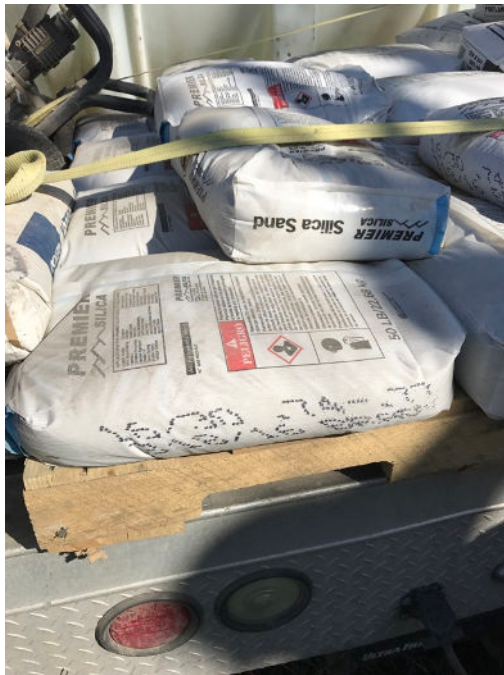
**Photograph 2 Notes:**

16/30 sand pack used in the boreholes from two feet above the top of the screen to the bottom of the borehole.

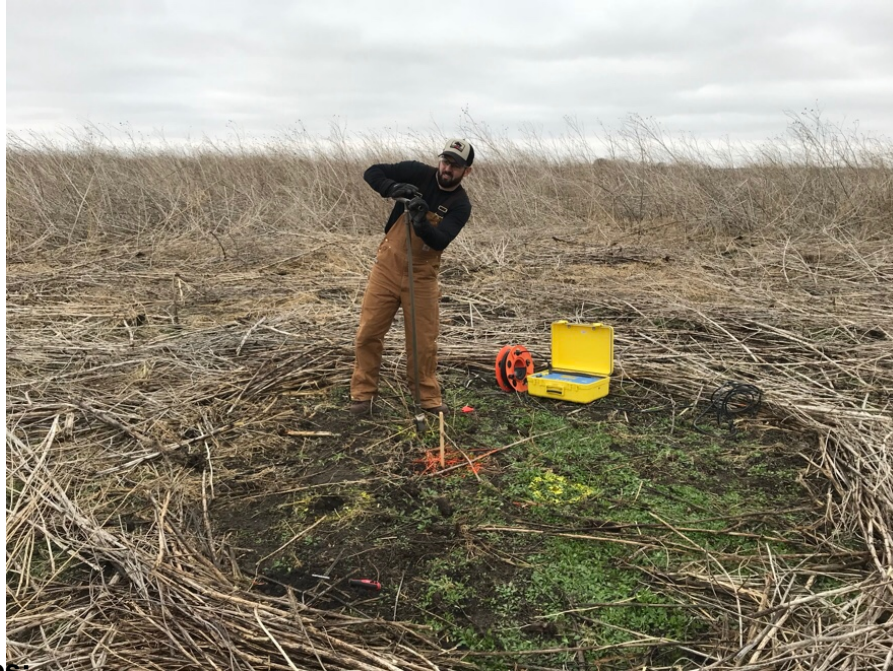
Photograph 1 Notes:

Monitoring well and protective bollards were hand augered to 4 and 2 feet, respectively, and scanned for UXO prior to advancement via mechanized equipment.

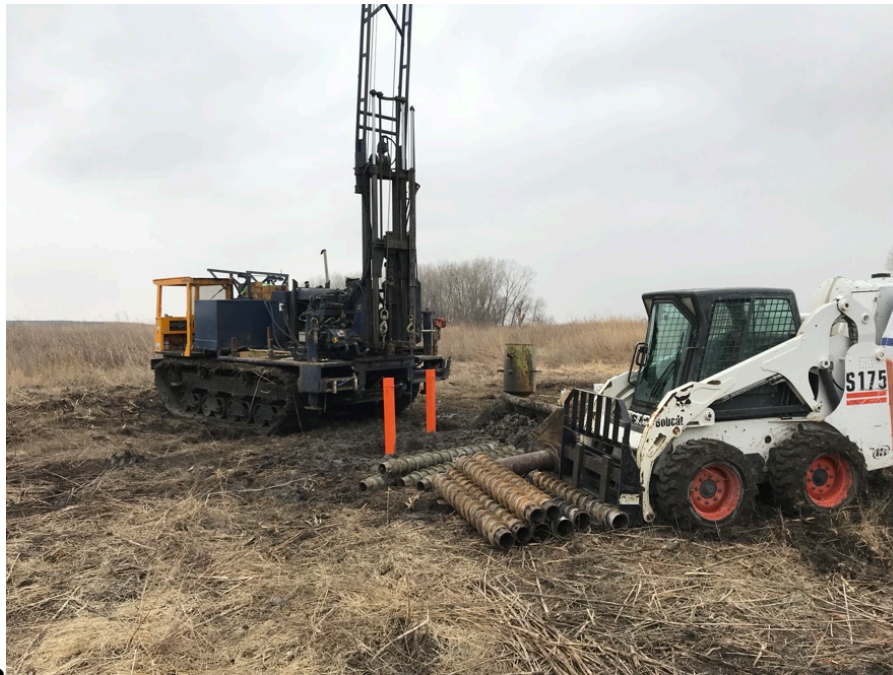
**Photograph 2 Notes:**

This track-mounted auger rig replaced the truck-mounted rig to better navigate the muddy terrain. This rig operated without issue in the poor site conditions.

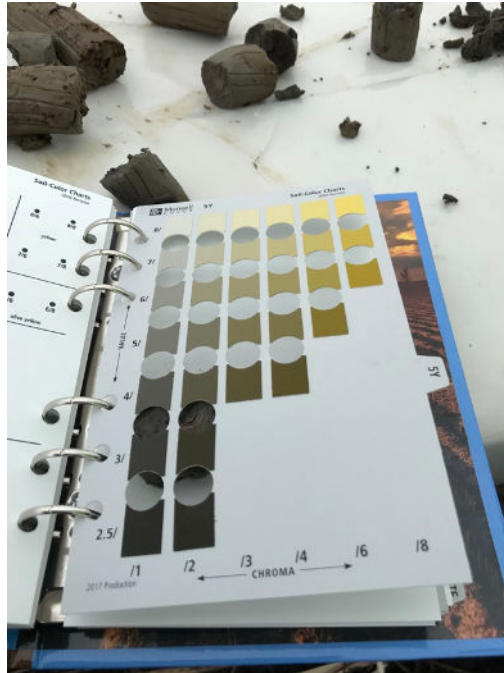
**Photograph 1 Notes:**

Munsell Soil Color book used to determine the appropriate color of soil. This photo is of 9.5-10.5ft. interval of BKRD-LGIA-MW16.

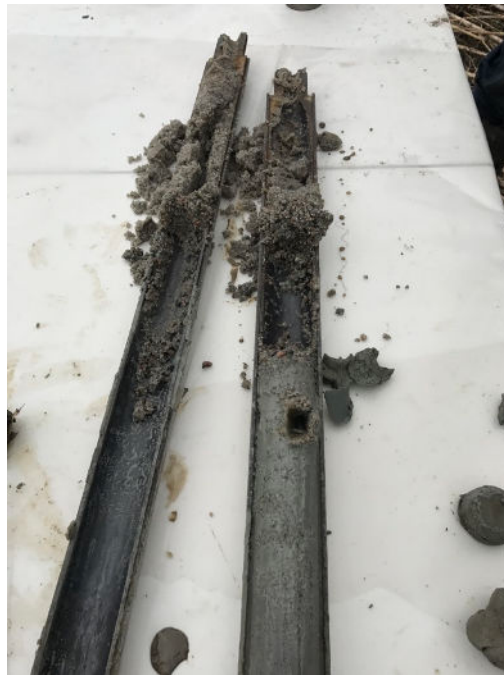
**Photograph 2 Notes:**

Track HSA encountered clay between 37.5-39.5ft. at BKRD-LGIA-MW16

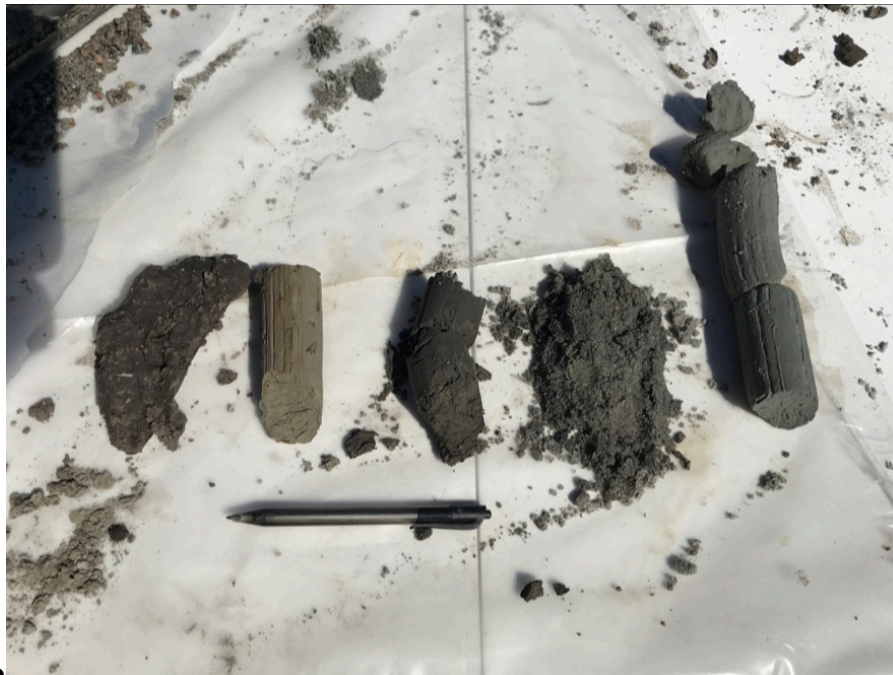
**Photograph 2 Notes.**

From left to right: topsoil, 2.5Y4/3 silty clay, and 5Y4/1 silty clay; UGIA and LGIA sand; and "Blue Clay" of the Fullerton Formation. This lithology is consistently encountered (in the aforementioned order) in the boreholes advanced throughout Background Area 3.

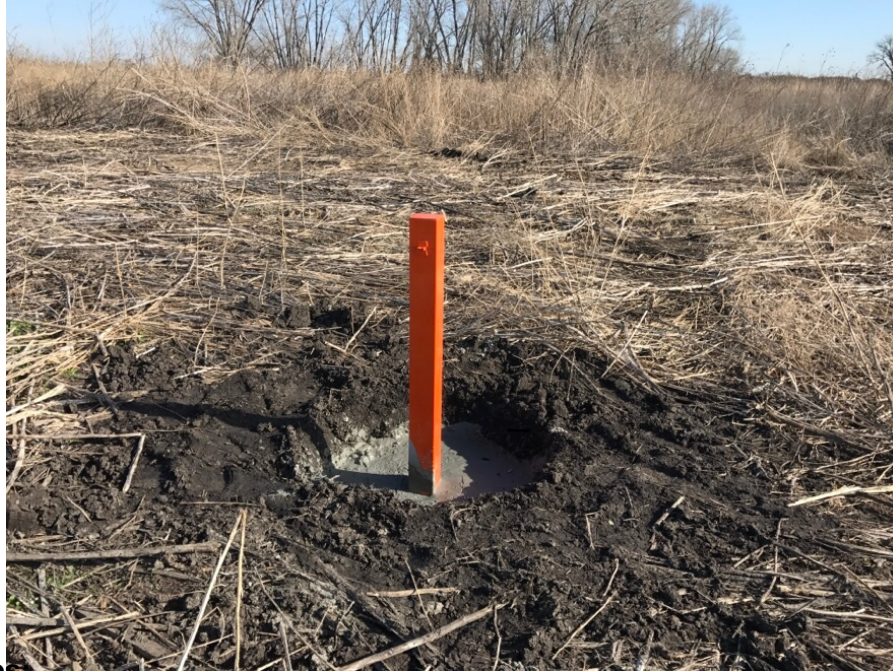
Photograph 1 Notes.

BKRD-LGIA-MW17 displays the well with orange casing and grout surface seal. This illustrates the stage prior to installation concrete pad and bollards.

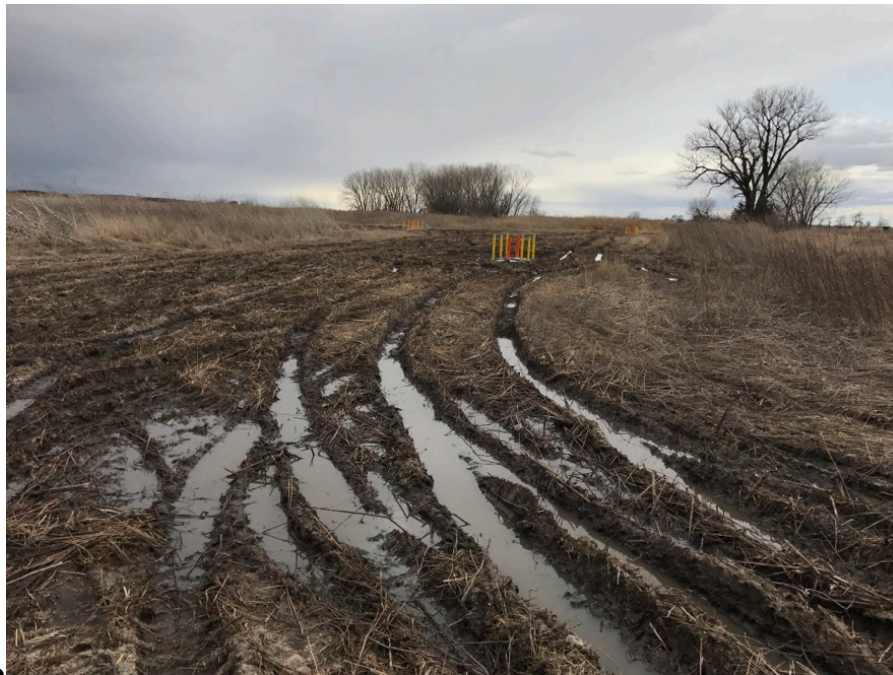
Photograph 2 Notes.

Upon demob from Background Area 3 on March 28th, the ATI crew inspected ground conditions on the Southern Fuse Destruction Area in Tract 20B to observe the response to several consecutive dry days. The area apparently remains soft and muddy.

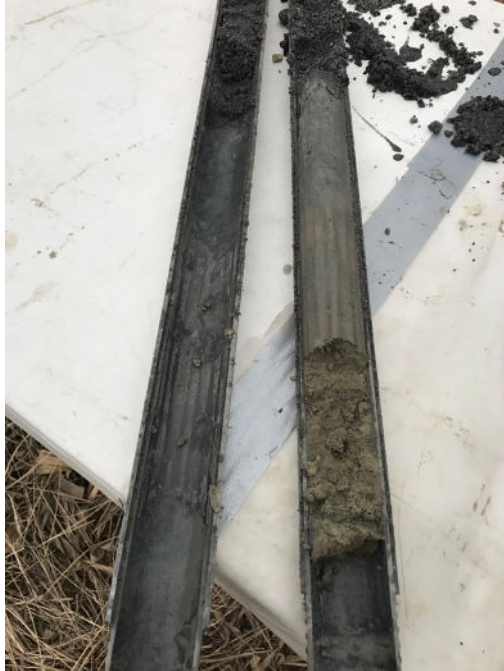
**Photograph 3 Notes:**

Clay encountered at the base of the Grand Island Aquifer 21B-DS-LGIA-MW05 has a higher silt content and color with the "Blue Clay" found at similar depths from track 20B and BKRD3.

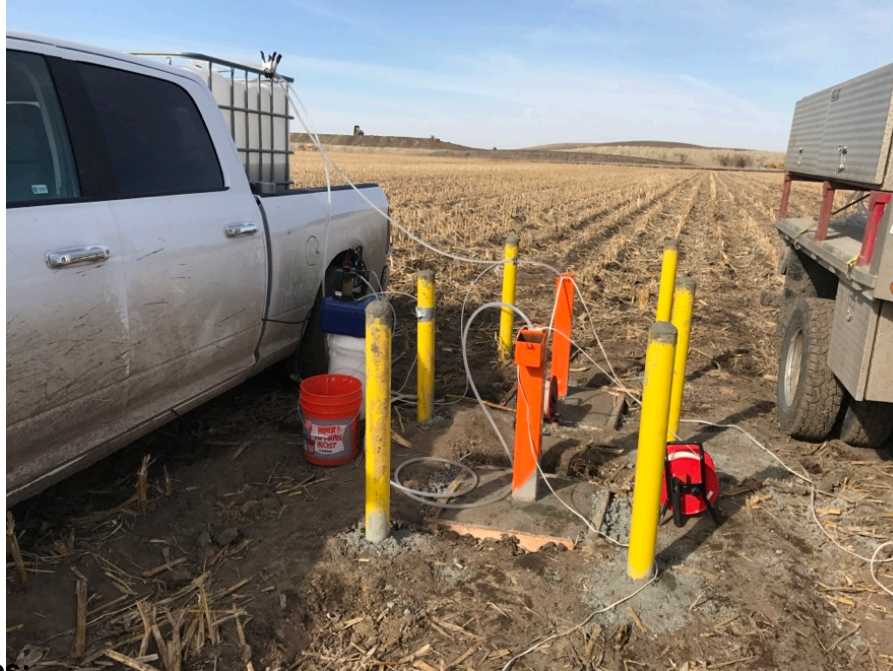
**Photograph 1 Notes:**

Wells 21B-BPA-UGIA-MW03 and 21B-BPA-LGIA-MW04 are shown being developed. The water depth, pH, conductivity, temperature, and turbidity were monitored continuously, and the wells were surged intermittently to remove fines from the screen and filter pack.

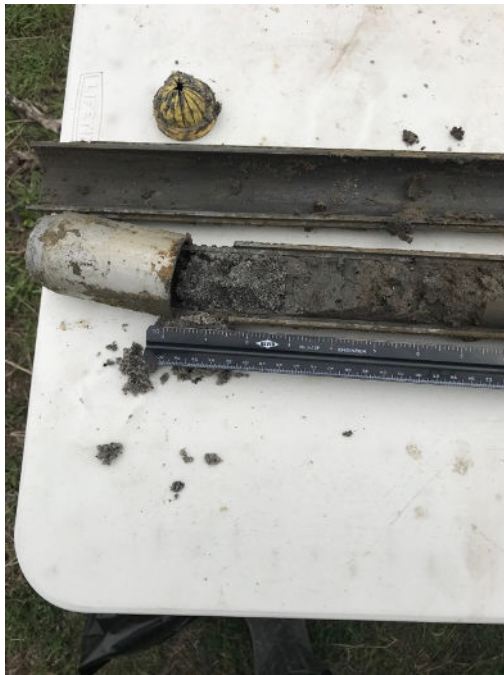
**Photograph 2 Notes:**

The clay/sand interface at 19C-LGIA-DPT12 can be seen in the split spoon advanced from 12.5-14.5 ft bgs. Per this observation, it was recorded that the top of the Grand Island Aquifer is 14.25 ft bgs at this location.

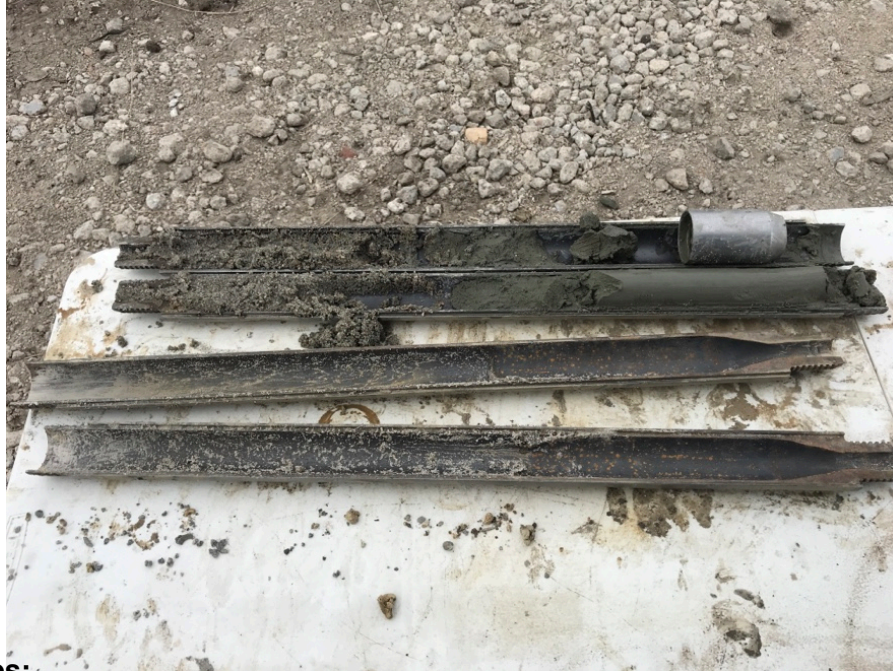
**Photograph 3 Notes:**

Blue clay encountered at 37 feet.

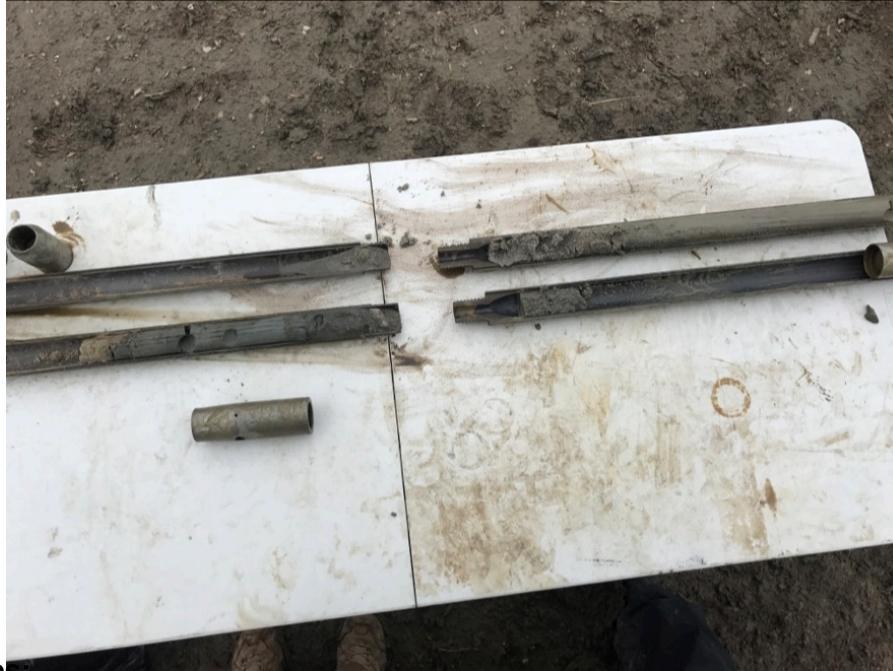
Photograph 1 Notes:

The two cores shown display the interface between clay and sand

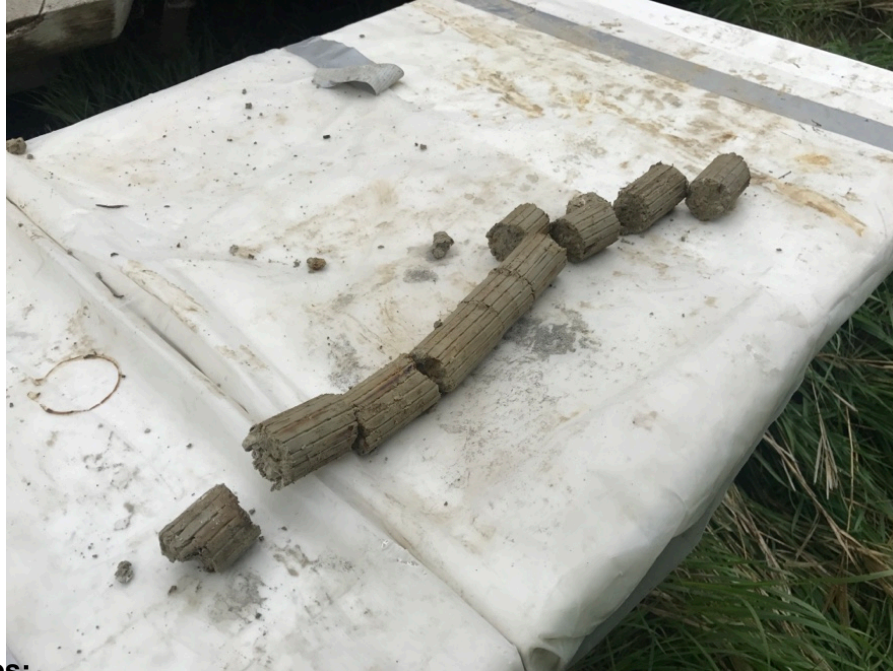
Photograph 1 Notes:

First split spoon sample recovered at location 21B-DS-LGIA-MW04 at interval depth of 3.5-5.5ft.

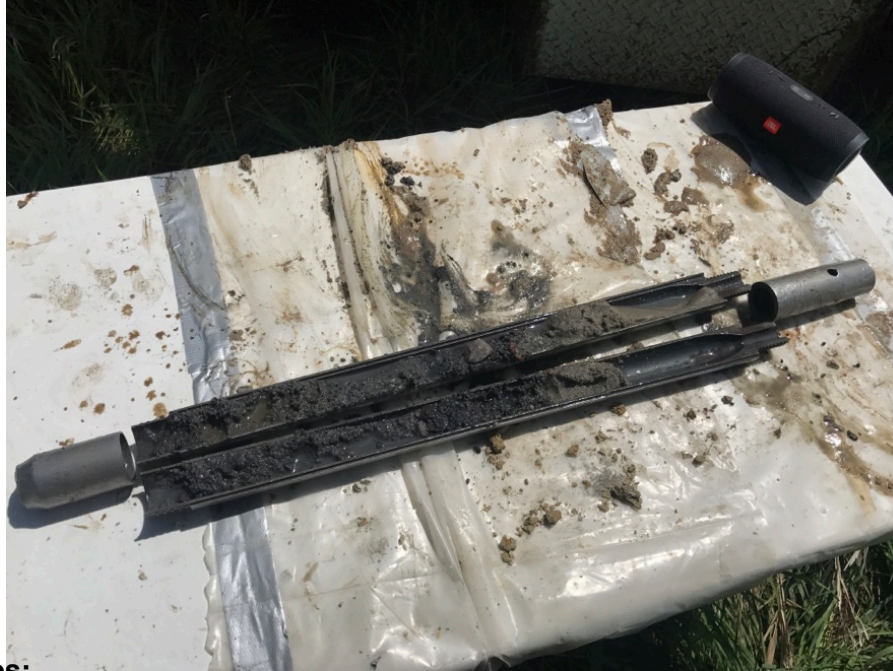
Photograph 3 Notes:

Split spoon sample at interval depth of 38.5-40.5ft.

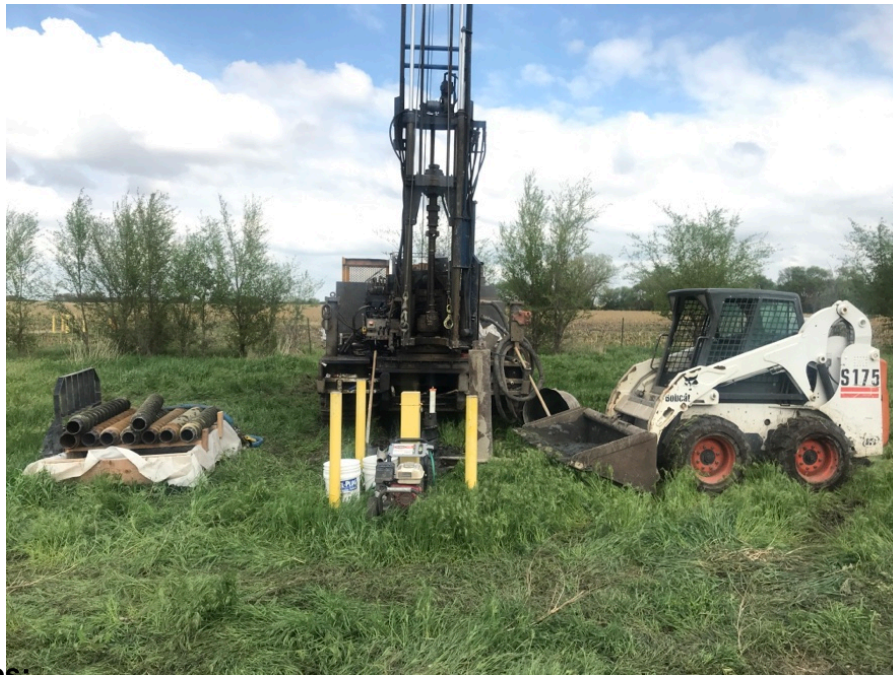
Photograph 4 Notes:

GSI equipment surrounds 21B-DS-LGIA-MW03 as they set the bentonite past 4pm and will be back tomorrow morning to complete the well installation.
