**ATI INC
CHAPP GRAND ISLAND SITE
GRAND ISLAND, NEBRASKA**

TRACT 20B MEC INVESTIGATION

INSTRUMENT VERIFICATION STRIP TECHNICAL MEMORANDUM

Subject: Contract No. W9128F-16-D-0014 Task Order 0002; Remedial Investigation /Feasibility Study Burning Grounds, Sanitary Landfill, and Pistol Range Areas (Remaining Property of the U.S. Government); Draft Instrument Verification Strip (IVS) Technical Memorandum for Person Portable EM61-MK2A Operations at Cornhusker Army Ammunition Plant, Grand Island, Nebraska.

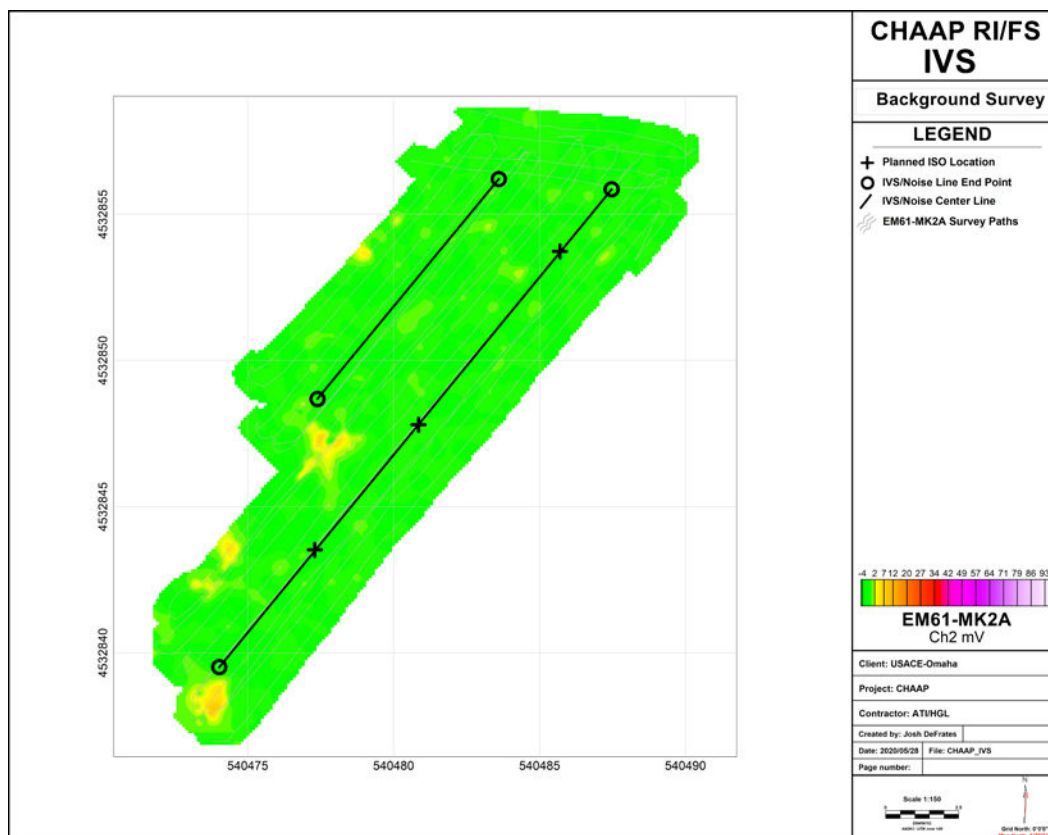
The field geophysicist scanned potential areas near the old magazine storage area with the EM61 and performed a full coverage survey at 0.75 m line spacing of the proposed IVS area on May 26th with sensor 1423W01. Positions for the EM61 background survey were determined with the RTK GPS. Three (3) anomalies were identified manually by the data processor with a minimum amplitude of 2.0 mV on Channel 2. The anomalies were investigated on May 27th by unexploded ordnance (UXO) personnel prior to burying the IVS items with several small nails recovered from the anomaly locations. The background survey was repeated again using Sensor 1910W01 and the results of the survey are presented in Figure 2. Sensor 1423W01 exhibited sporadic, low amplitude noise and was not used further for the IVS surveys.

Figure 2 – IVS Background Survey

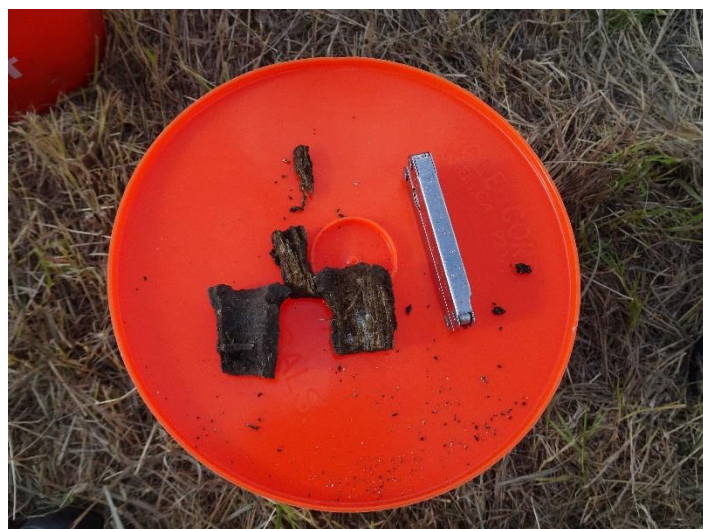
Munitions Debris excavated in the ABA

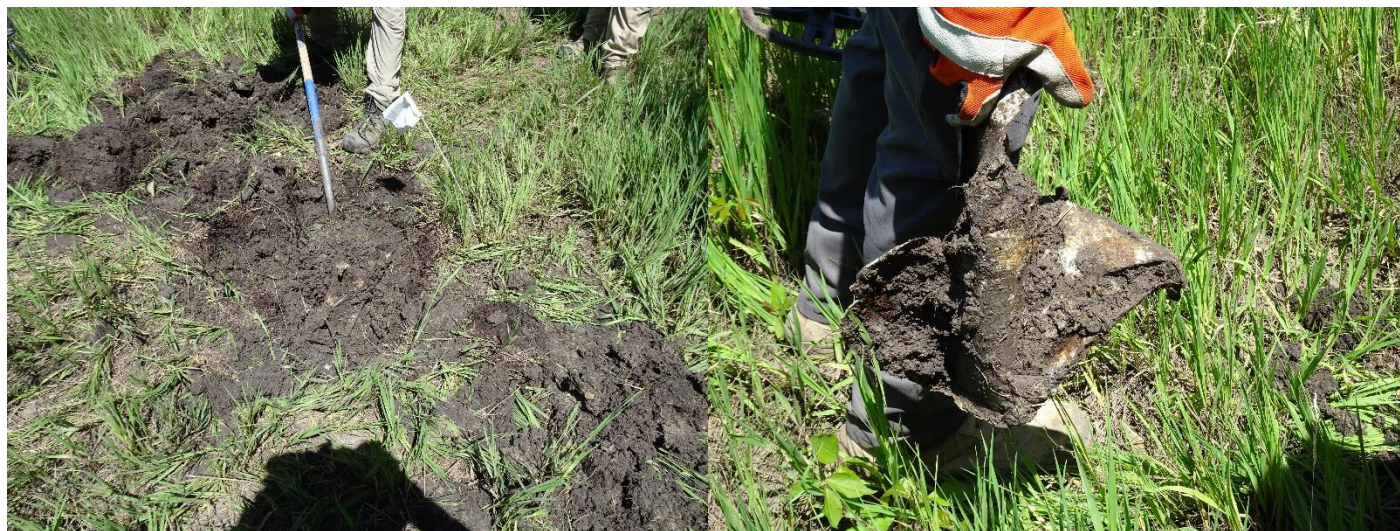
Anomaly investigation in the SFDA. Scrap metal from land fill activities

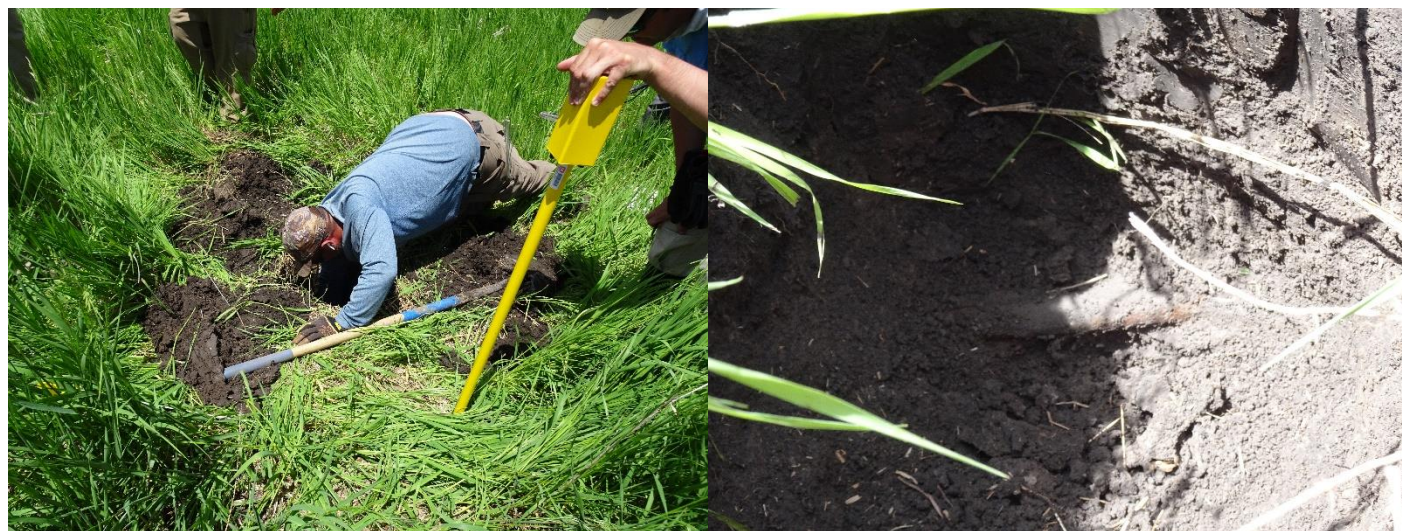
Anomaly investigation in step out transects at ABA. Utility located approximately 2' below surface.
